The Oroville Dam 2017 Spillway Incident

And Lessons from the Feather River Basin

September
2017

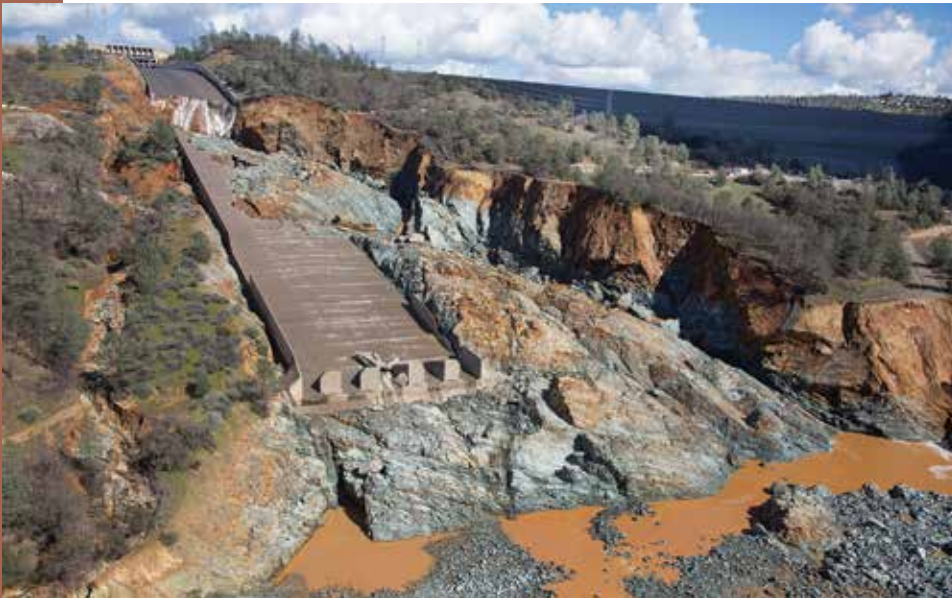
Oroville Dam Spillway, Feb. 27, 2017. The Oroville dam main spillway after spill flow releases ceased for repair inspections. Oroville Dam is in the shadow on the upper right. *Source: Dale Kolke, CA Dept. of Water Resources (hereby DWR).*

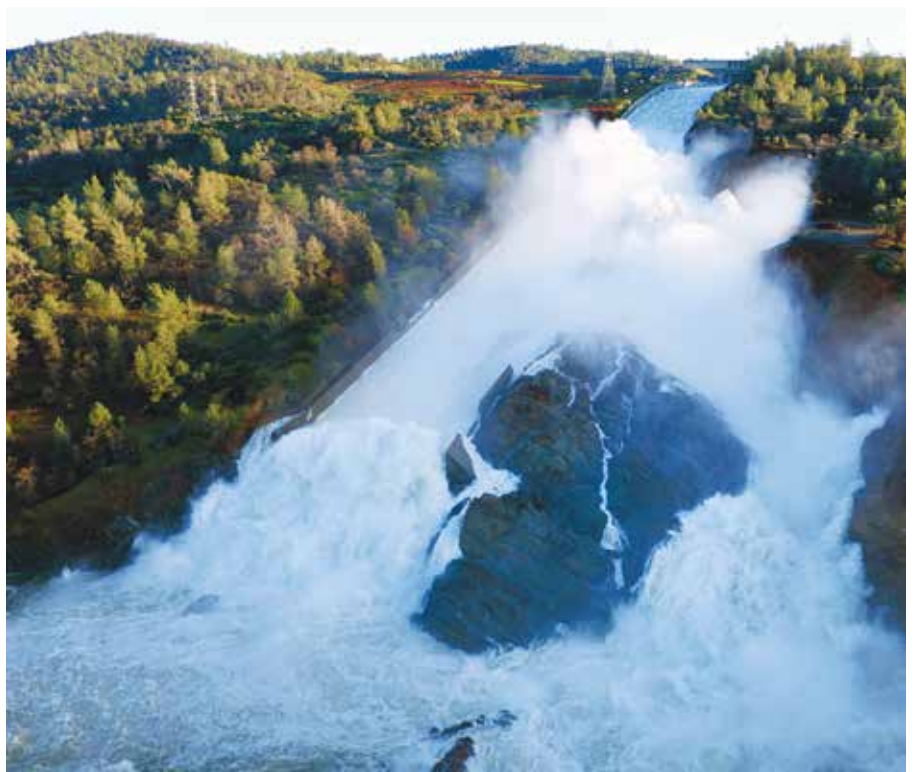
Aerial view from a DWR drone shows a 55,000 cfs release down the main spillway. Despite existing damage to the main spillway, these high flows were released as the reservoir level exceeded 901 ft elevation, and water spilled at 5,000 to 10,000 cfs over the Oroville emergency spillway.

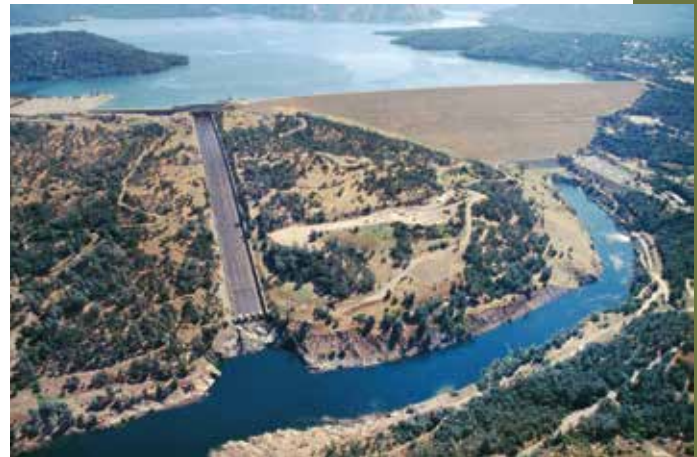
Oroville Dam. This aerial photograph was taken before 2017 and shows the dam on the right side, the concrete main spillway in the middle, and the emergency spillway on the left with a vegetated hillside below. *Source: DWR.*

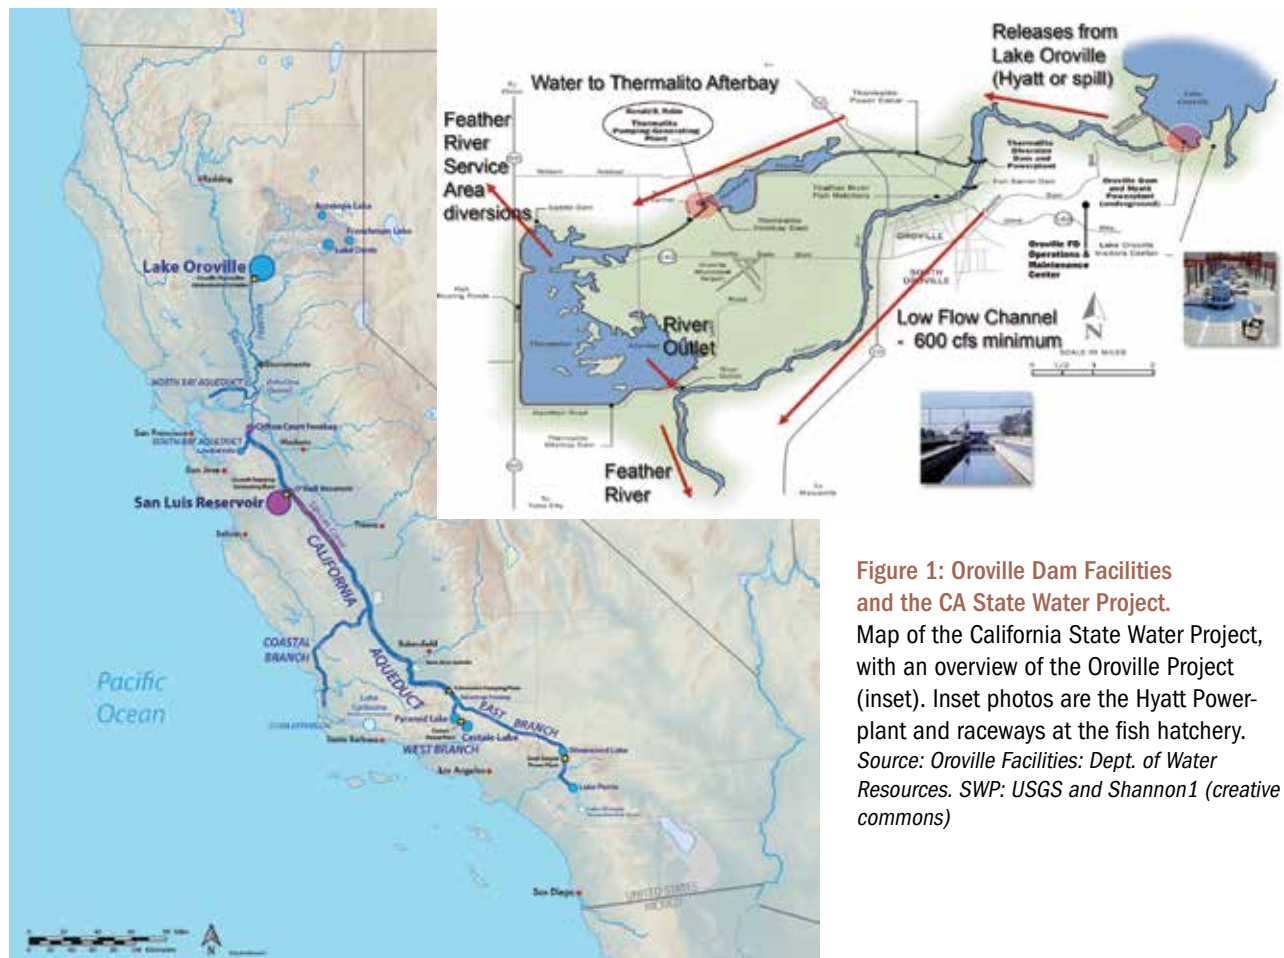
Figure 1: Oroville Dam Facilities and the CA State Water Project. Map of the California State Water Project, with an overview of the Oroville Project (inset). Inset photos are the Hyatt Powerplant and raceways at the fish hatchery. Source: Oroville Facilities: Dept. of Water Resources. SWP: USGS and Shannon1 (creative commons)

Water (regardless of its source) that reaches the Delta is either diverted for local (largely agricultural) use, flows through Suisun, San Pablo, and San Francisco bays to the Pacific Ocean, or is diverted by the Central Valley Project or the State Water Project (SWP). SWP facilities in the Delta include the North Bay Aqueduct that diverts water to Solano County. The SWP’s largest facility is the California Aqueduct. Most of the water in the California Aqueduct is delivered to the San Joaquin Valley and Southern California, but some is delivered to the southern Bay Area via the SWP’s South Bay Aqueduct (Figure 1).

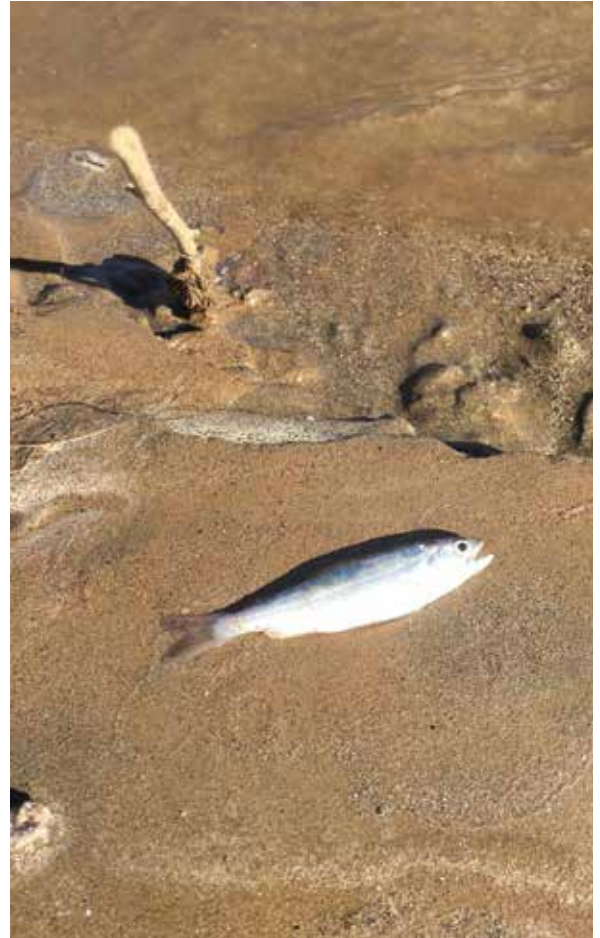
Salmon smolt stranded during rapid flow decreases in the Feather River, April 2017.

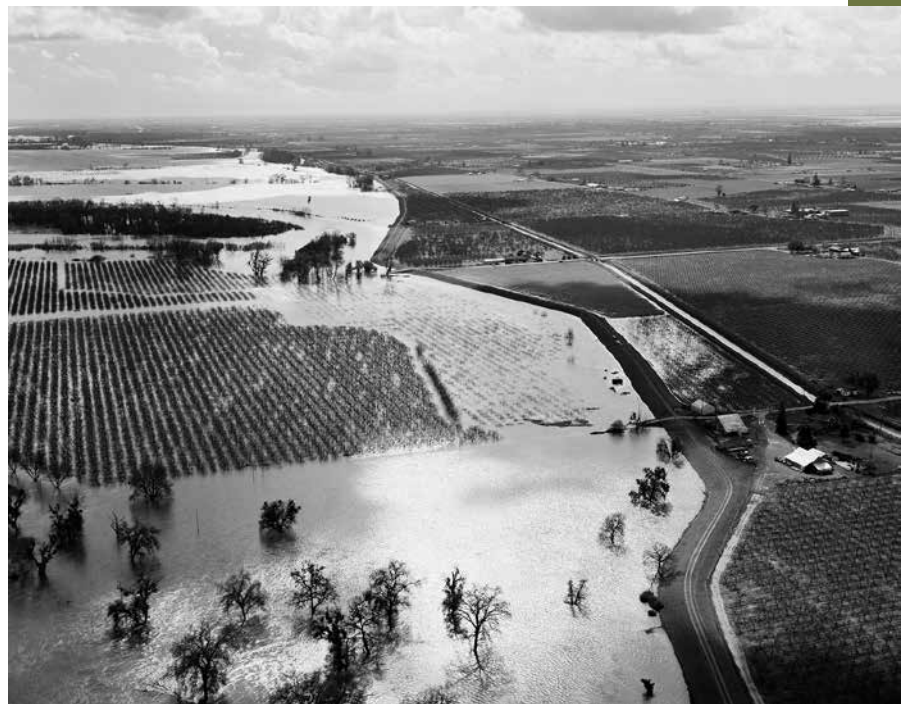
The Oroville Incident, Feb. 1986. The west levee of the Feather River does its job east of Highway 99 and near Live Oak in Sutter County. Photo taken February 20, 1986. Source: Norm Hughes / California Department of Water Resources

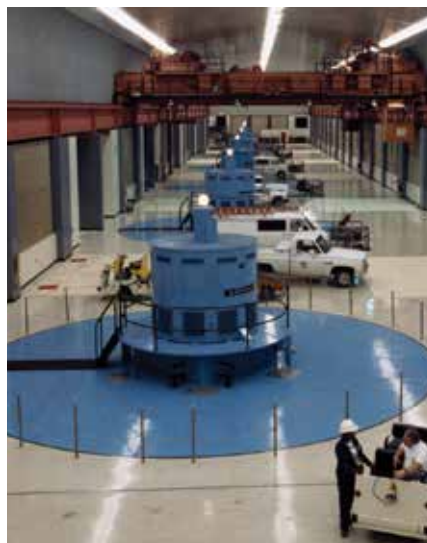
Oroville Hydropower Facilities. Located beneath Oroville Dam, the Edward Hyatt Powerplant contains six units, three to pump water and three to generate power for the operational needs of the DWR facility. *Source:* DWR. Ronald B. Robie Thermalito Pumping-Generating Plant, located at the Thermalito Afterbay, at sunrise 11/23/12. *Source:* Florence Low, DWR.

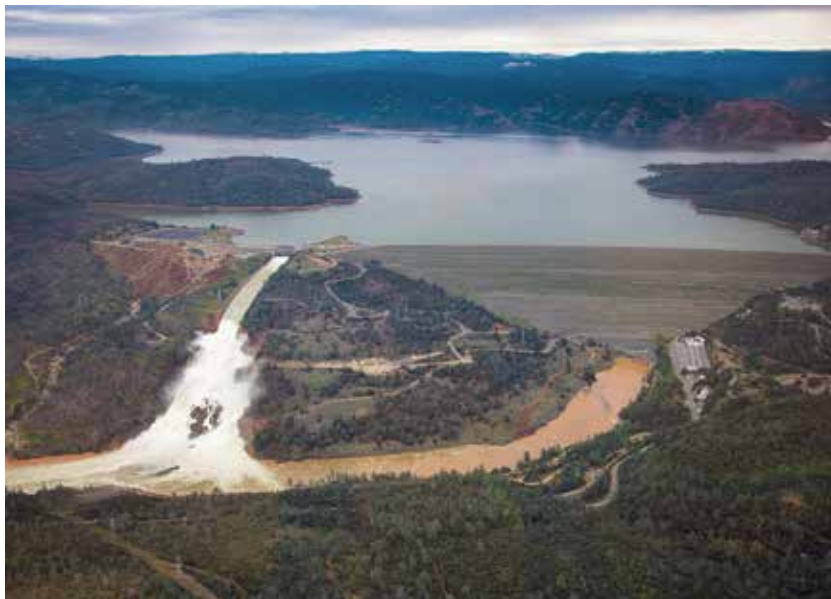
Oroville Dam's Main Spillway at 100,000 cfs. An aerial view looking eastward toward Oroville Dam and Reservoir. The emergency spillway is on the left (note eroded red dirt area) and the damaged main spillway left of center. Oroville Dam is on the right. An outflow of 100,000 cfs travelled down the main spillway on Feb. 15, 2017. Source: Dale Kolke, DWR.

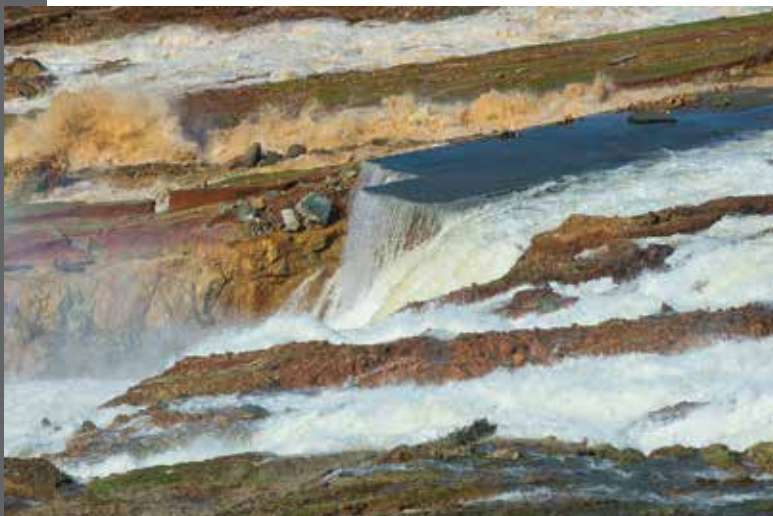
Emergency Spillway Flows and Erosion. Water flows over the Emergency Spillway for the first time on Feb. 12, 2017, eroding gullies and destroying a roadway. *Source: Kelly M. Grow, DWR.*

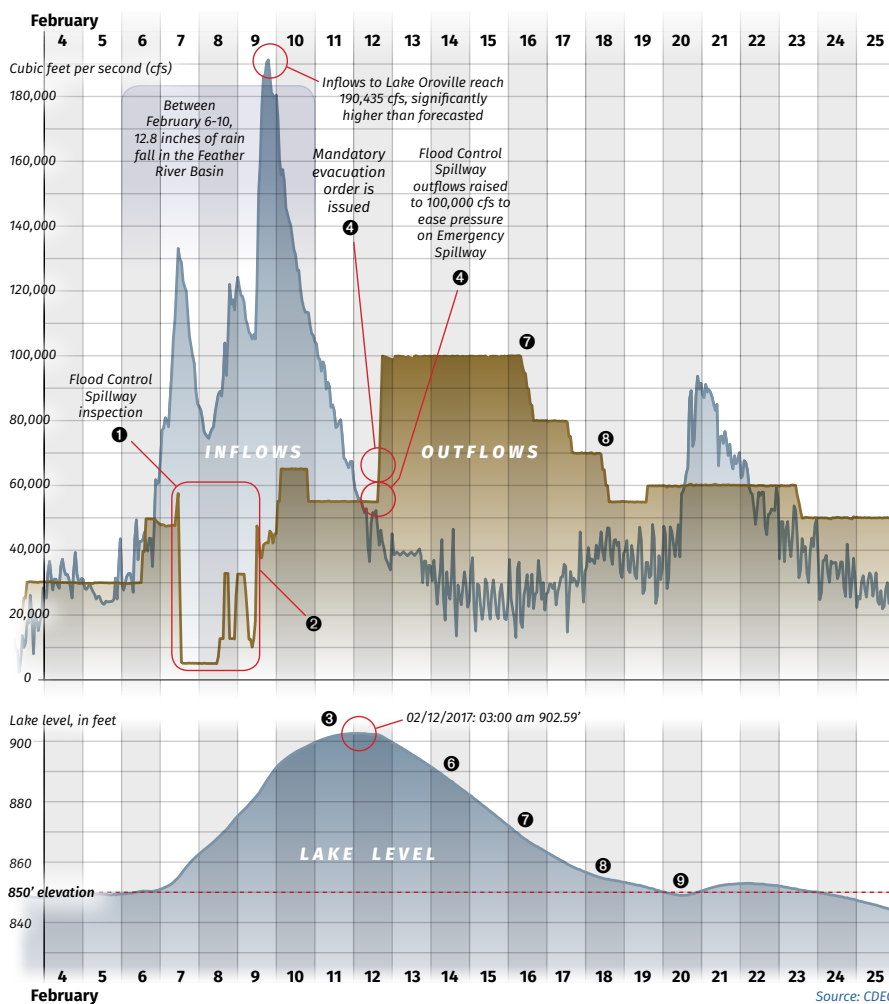
Oroville Spillway Timeline - February 2017

February 7: Reservoir inflows exceed 130,000 cfs, and main spillway releases peak at 54,500 cfs. Unusual flow pattern observed. Releases are stopped, and a large crater/hole is observed. (1)

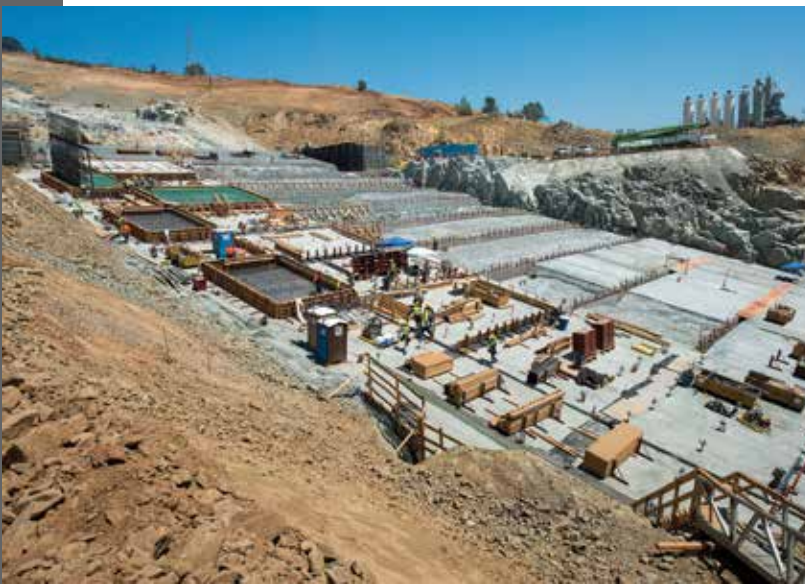
Oroville Dam Main Spillway Repair. Image date: August 9, 2017.
Source: Florence Low, DWR.

By late spring, the reconstruction began in earnest, with the goal of reconstructing the lower main spillway and its foundations and making smaller repairs to the upper spillway during the 2017 construction season. The plan for the emergency spillway is to build a cutoff wall by November 1 that would be located downhill on the hilltop to prevent headcutting, if used. At a later time, the spillway lip would receive a roller-compacted-concrete buttress and a “splash pad” (or “apron”).⁶³ Transmission towers and powerlines are being relocated out of harm’s way.⁶⁴

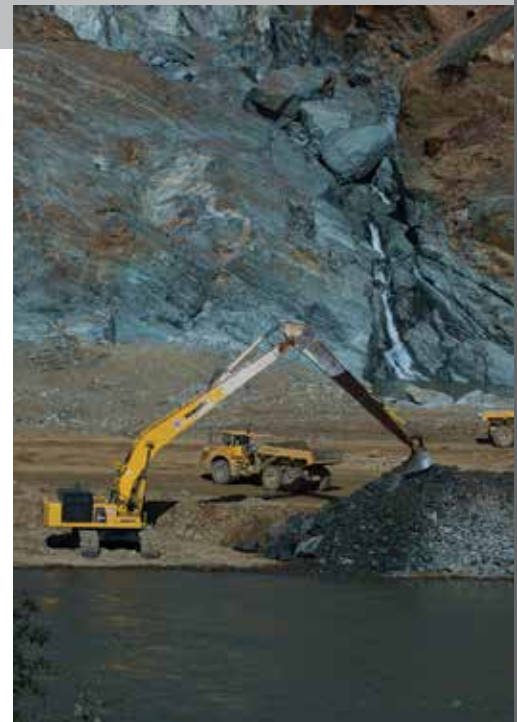
Removal of debris from Feather River diversion pool. Source: DWR

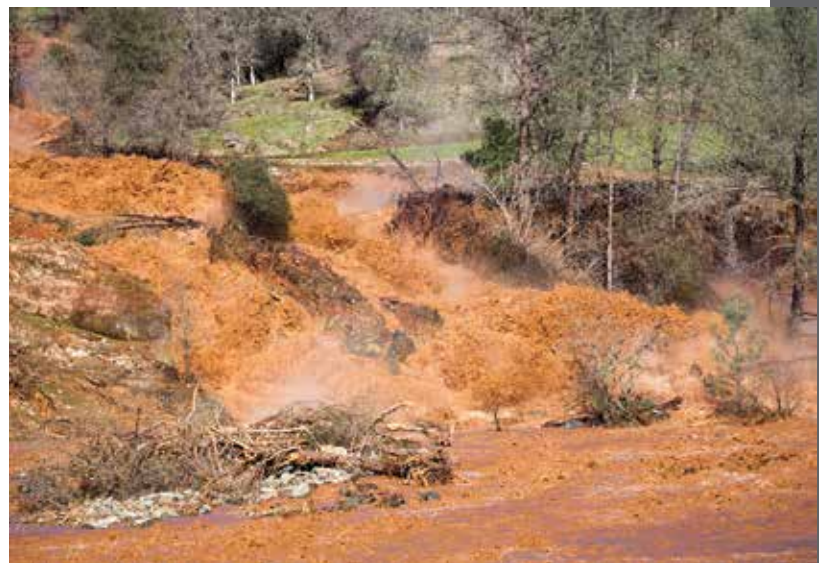
Oroville Dam Spillway Erosion, Feb. 11, 2017. Water and debris from the emergency spillway failure flow into the diversion pool just downstream of the dam. *Source: Dale Kolke, DWR.*

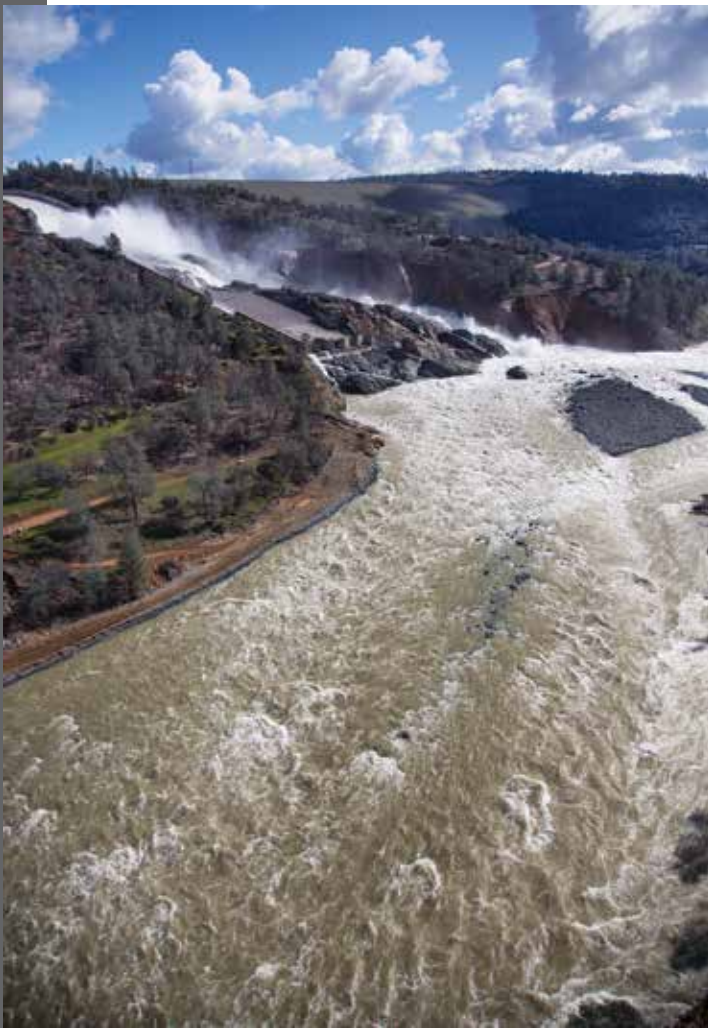
An aerial view of the diversion pool on the Feather River as outflow from the damaged Oroville Dam spillway was being reduced from 50,000 cubic feet per second (cfs) to zero on February 27, 2017. Source: Dale Kolke / California Department of Water Resources

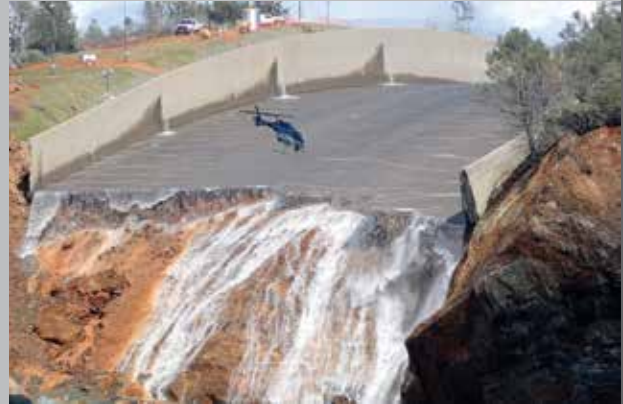
Main Spillway, Feb. 27, 2017. As DWR decreases flows on the damaged main spillway to assess damages.
Source: Bill Husa, Chico Enterprise-Record.

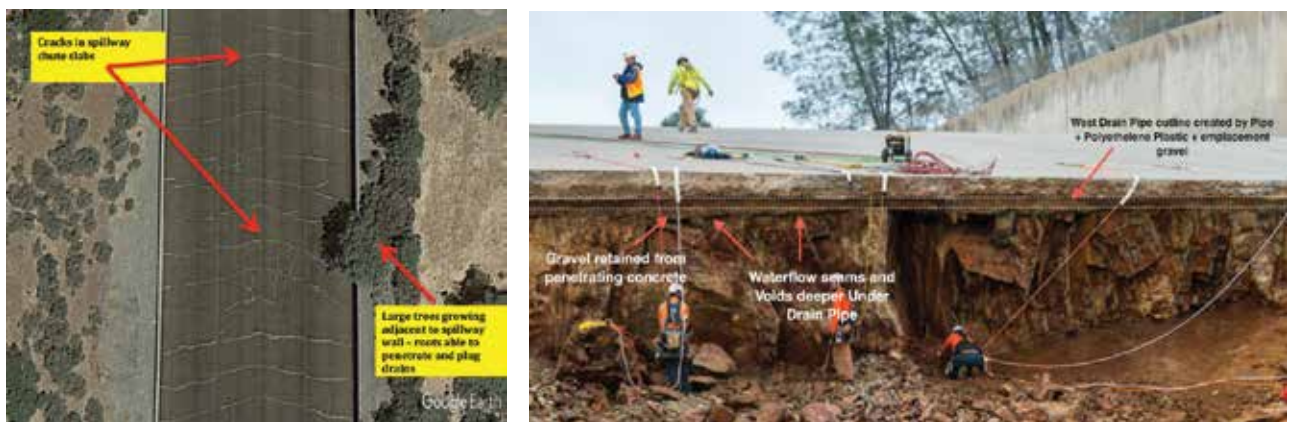
Oroville Forensics. Bea points out the many cracks on the surface of the spillway, as well as trees growing too close to the edge of the structure in this 2010 satellite image (left). Bea believes a hidden drain pipe proved the critical weakness along the spillway (right). *Image source: Bea, Root Causes Analysis, using GoogleEarthPro and DWR images.*

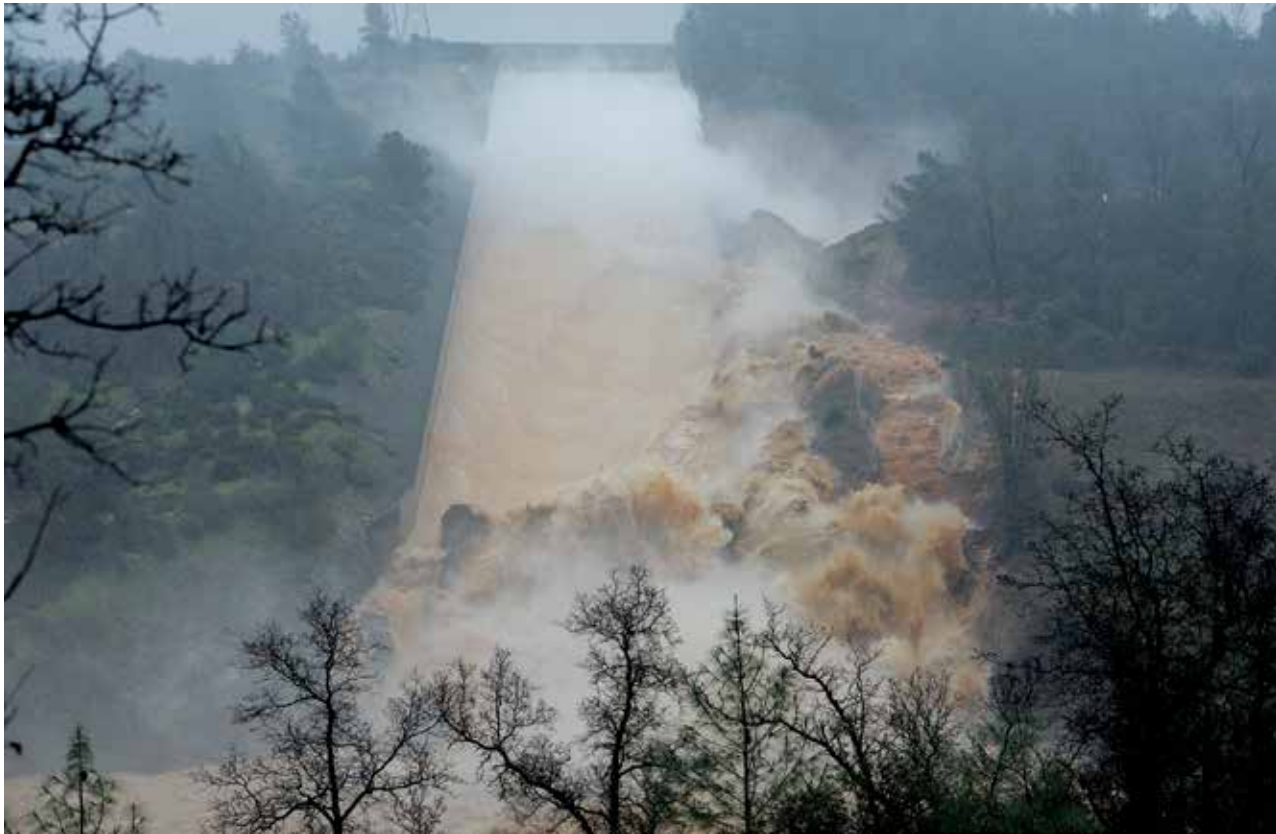
The Oroville Incident, Feb. 2017. As the Oroville Reservoir main spillway crumbles, mud, rocks and concrete flow in to the Feather River on February 8, 2017. *Source: Bill Husa, Chico Enterprise-Record.*

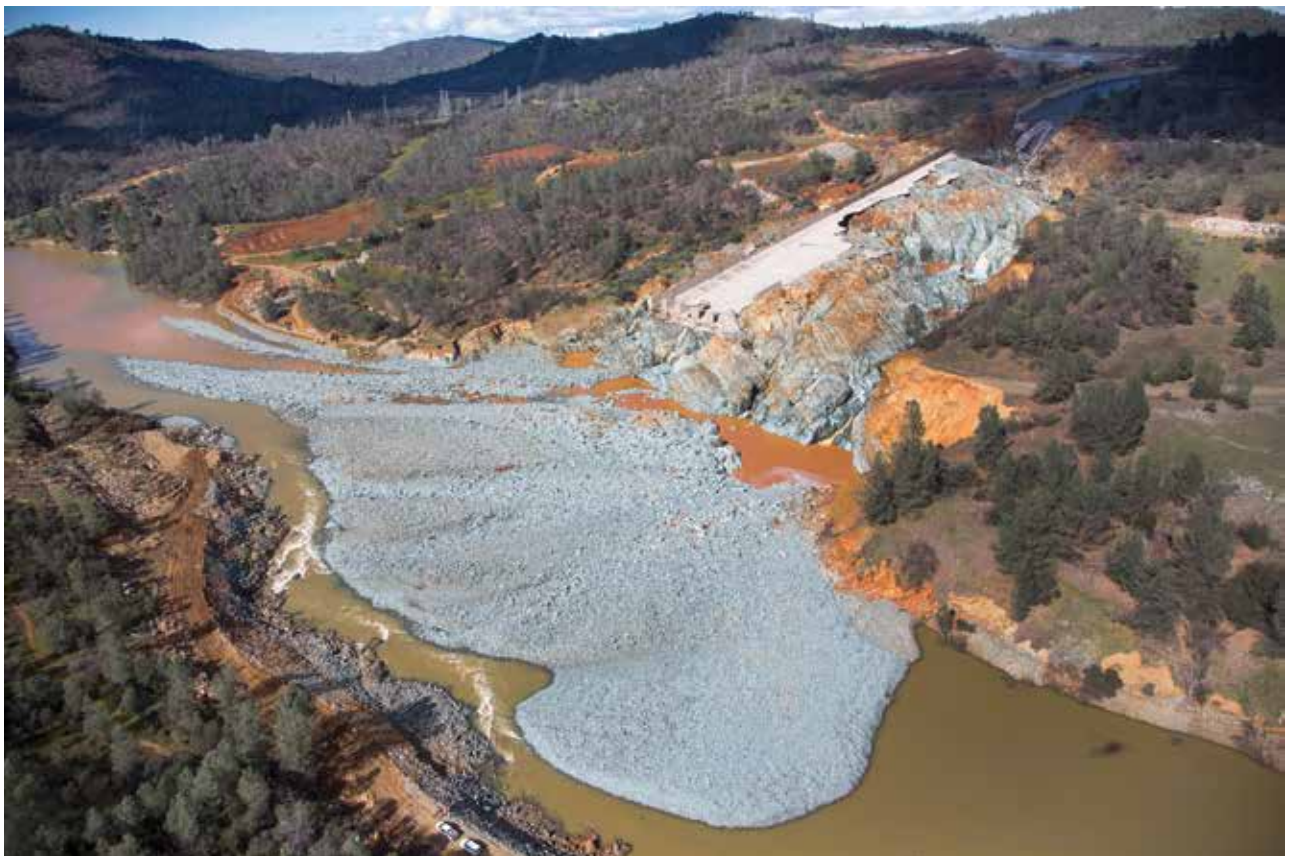
Damaged Main Spillway, Feb. 27, 2017. An aerial view of the damaged main spillway and resulting debris field. Flows were reduced from 50,000 cfs to zero on Feb. 27 to allow reduction of the water elevation in the diversion pool, removal of debris, and re-initiation of power generation at the Edward Hyatt powerhouse. *Source: Dale Kolke, DWR.*

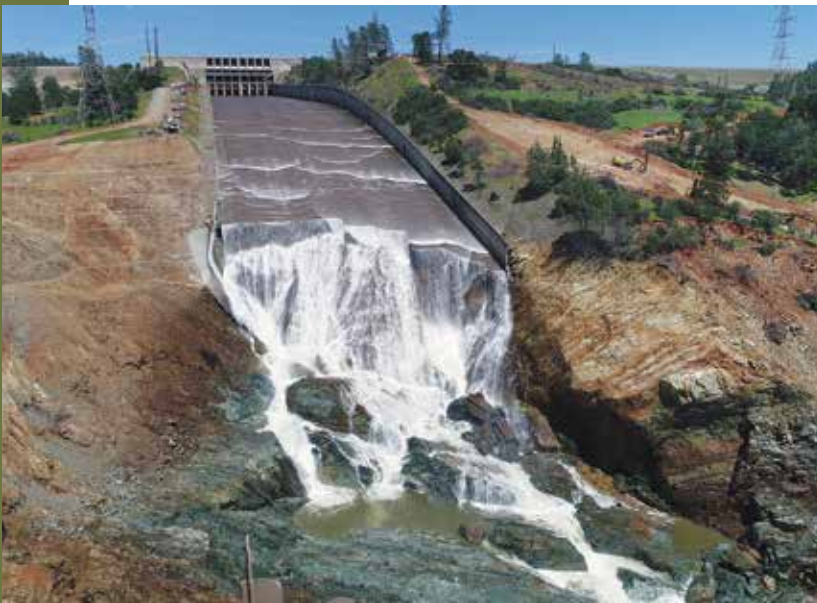
Main Spillway Erosion: A view of the erosion cavity at the Oroville main spillway – an infrastructural failure combining design, construction and maintenance issues. May 1, 2017. Source: Mike Burns, DWR.

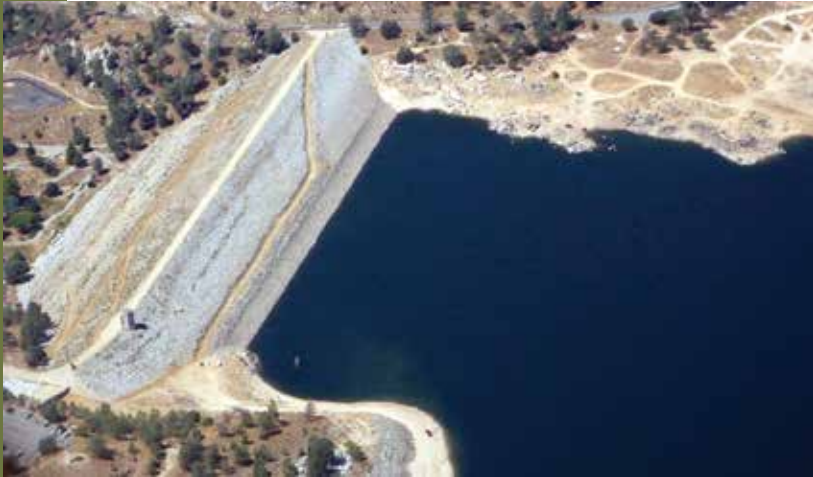
Isabella Dam on the Kern River gets a major seismic upgrade by the Army Corps of Engineers to reduce the risk of dam failure.
Source: www.wikiwand.com/en/Isabella_Dam

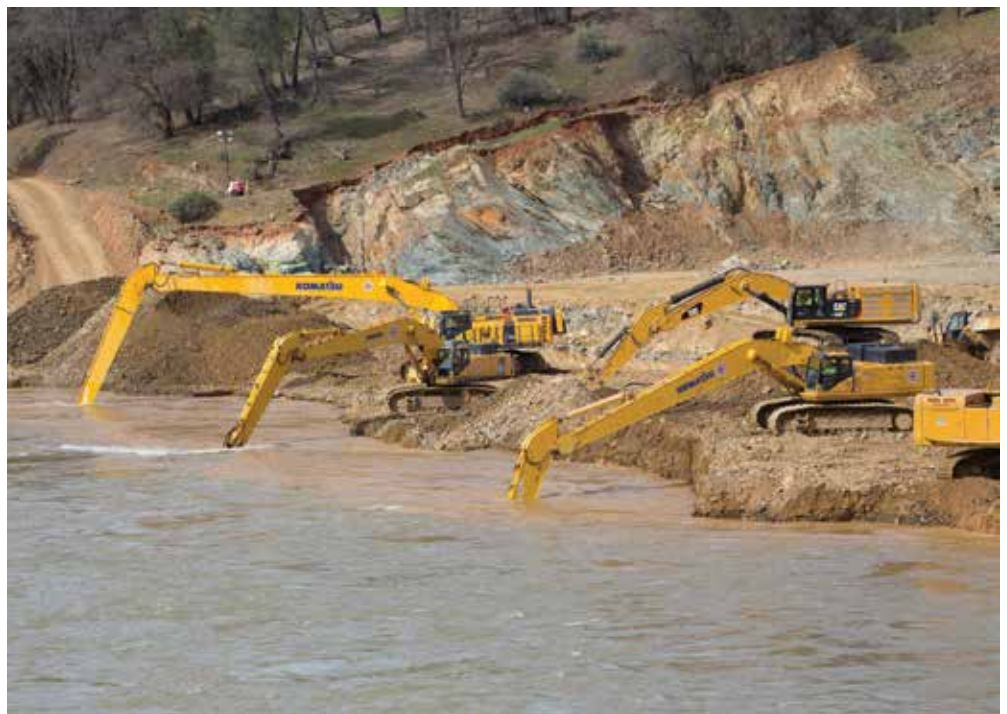
Photo taken on March 9, 2017. Approximately 715,000 cubic yards of material were removed from the debris pile by this date.

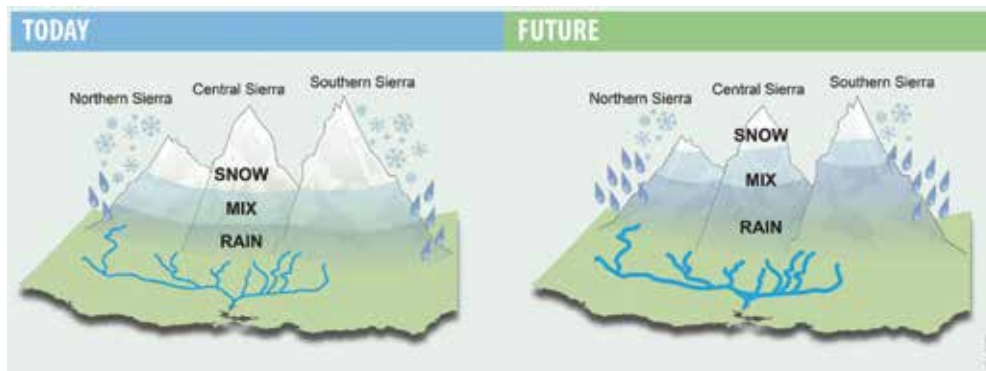
A Changing California Climate. Projections include intensified extreme precipitation events, with more rain and less snow, and more rapid snowmelt. *Source: CVFPP 2017 Update*

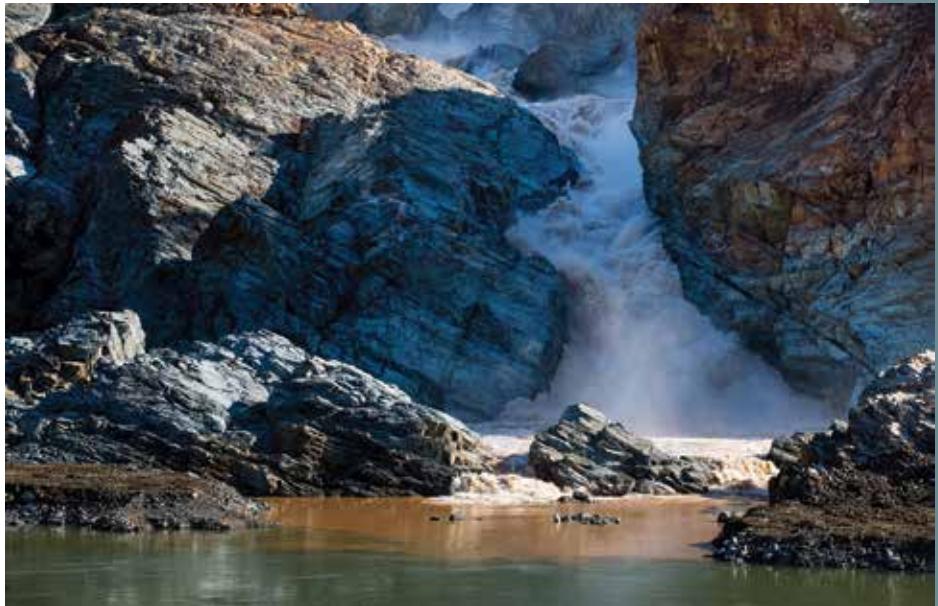
Flows leaving the damaged Oroville Main Spillway enter the diversion pool of the Feather River, April 14, 2017. Source: Kelly M. Grow, DWR.

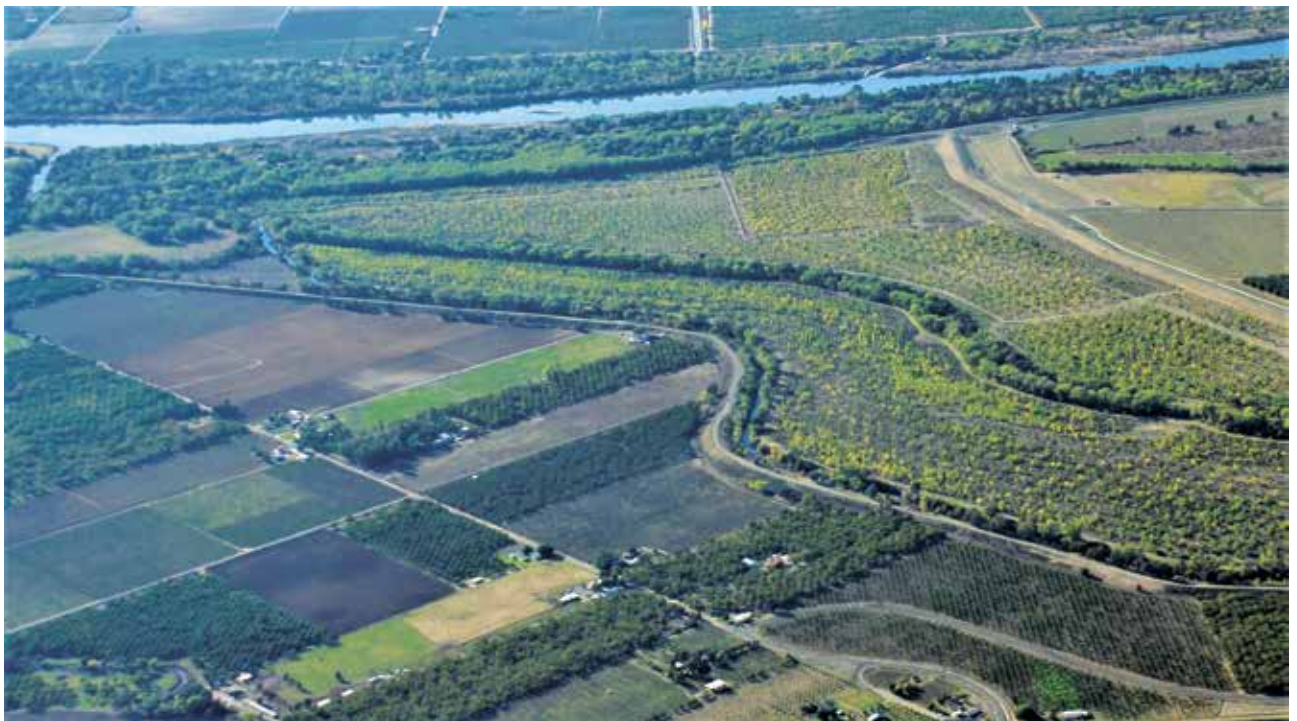
The Bear River Setback Levee provides 625 acres of restored floodplain area. Source Eric Ginney / Zeke Lunder.

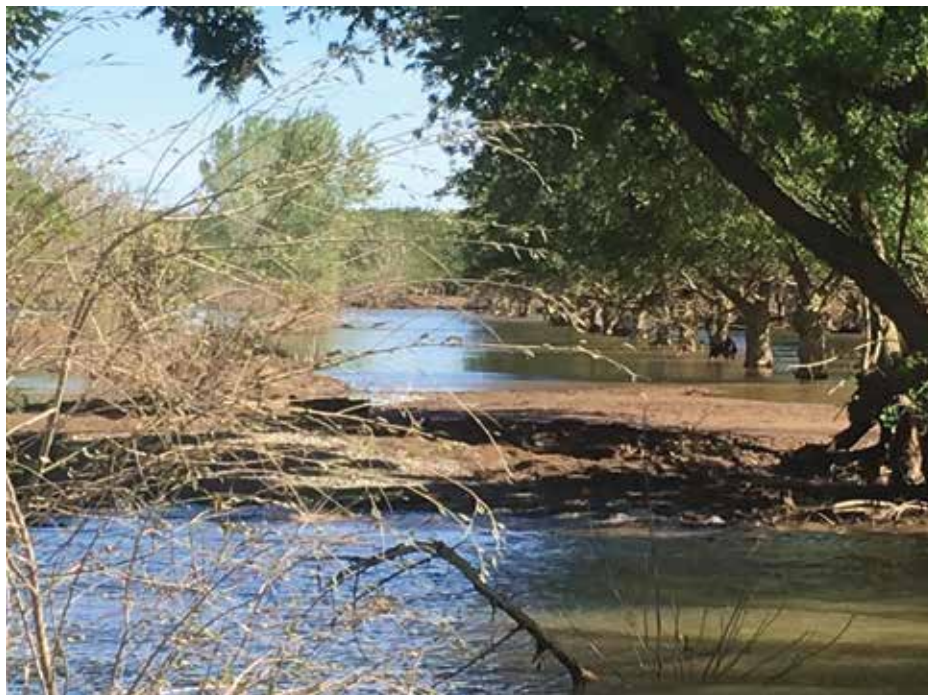
Inundated orchard in the Feather River floodplain and new sediment deposits, March 2017. Source: J. Stone, *Nor-Cal Guides & Sportsmen Assoc.*

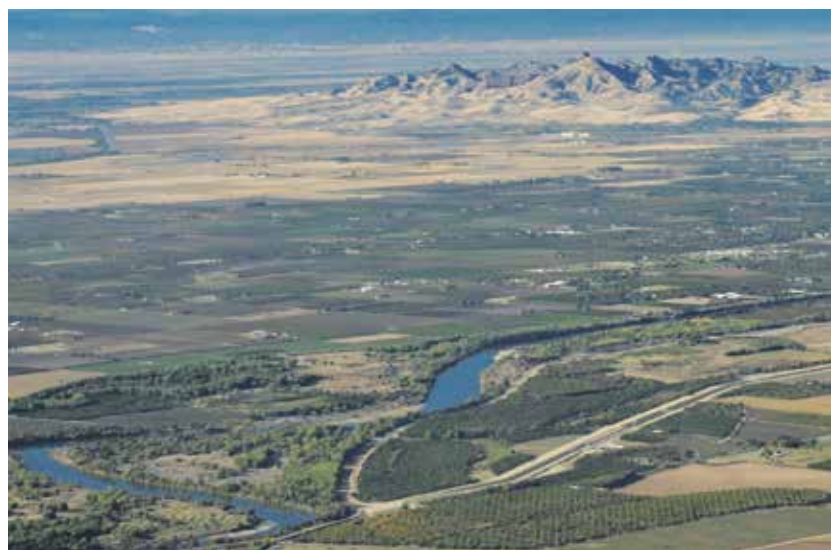
The Feather River Setback Levee. Source: Eric Ginney / Zeke Lunder.

The Feather River Setback Levee helped further local Yuba County flood-management goals and larger regional flood protection by widening the Feather River floodway and creating nearly 1,500 acres of riparian floodplain habitat for fish and wildlife. Completed in 2010, the levee improvement projects consist of three different segments, with the bulk of the project’s \$192 million cost paid by DWR (\$138.5 million), and Yuba County. Yuba County Water Agency, Reclamation District 784, and one local landowner partnered to provide \$53.3 million in local funding.

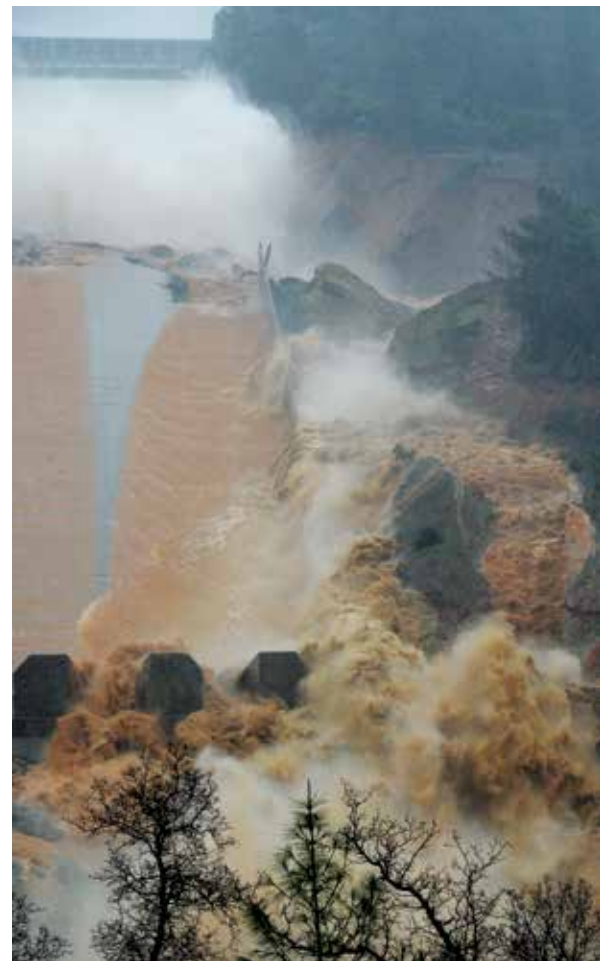
Damaged Oroville Main Spillway.
Mud and debris tumble down the newly eroded channel alongside the Oroville main spillway on Feb. 8, 2017.
Source: Bill Husa, Chico Enterprise-Record.

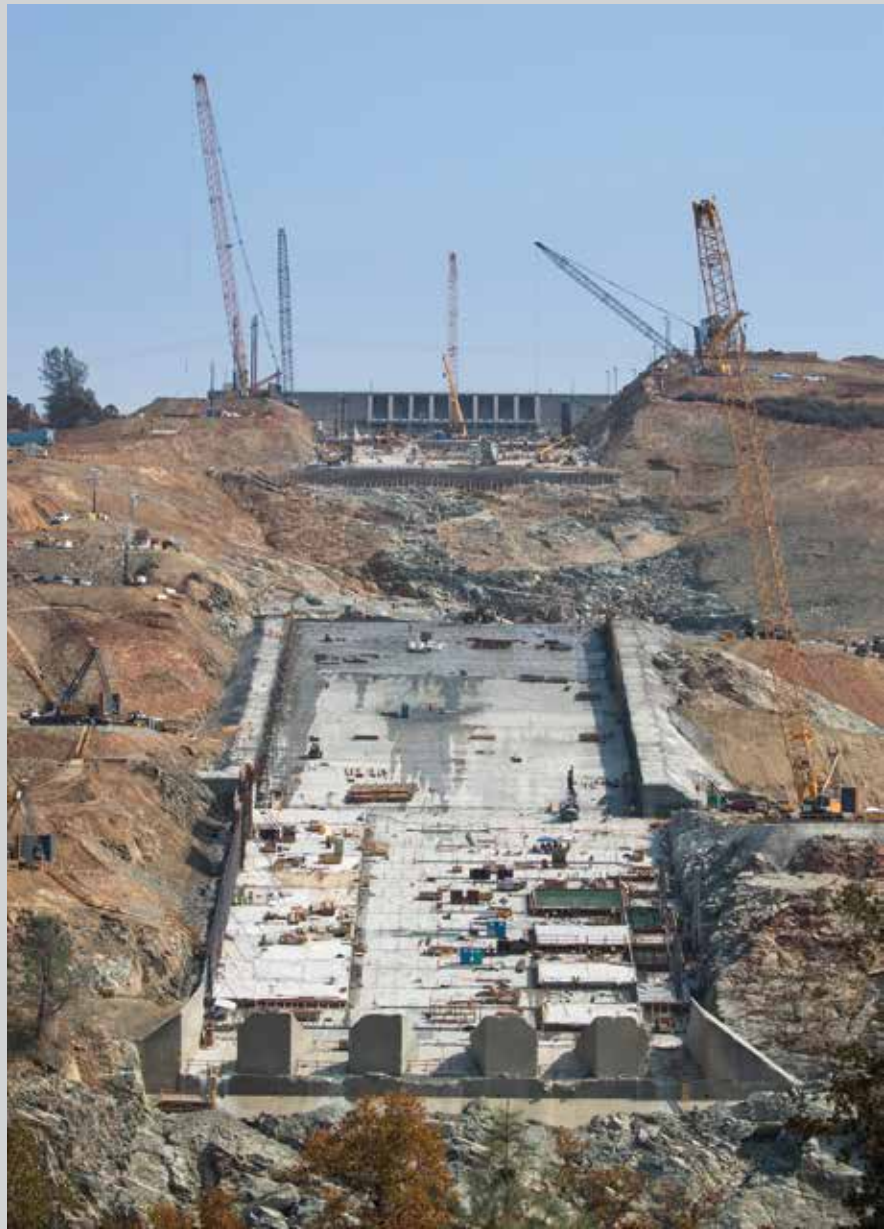
Back cover photo image: Crews continue the placement of rebar panels for the new side walls on the lower chute of the Lake Oroville flood control spillway in Butte County, California. Photo taken September 5, 2017.
Source: Ken James / California Department of Water Resources,
