DAM REMOVAL SUCCESS STORIES

*RESTORING RIVERS
THROUGH SELECTIVE
REMOVAL OF
DAMS THAT DON'T
MAKE SENSE*

DECEMBER 1999

***This report was prepared by
Friends of the Earth, American Rivers, and Trout Unlimited
in December 1999.***

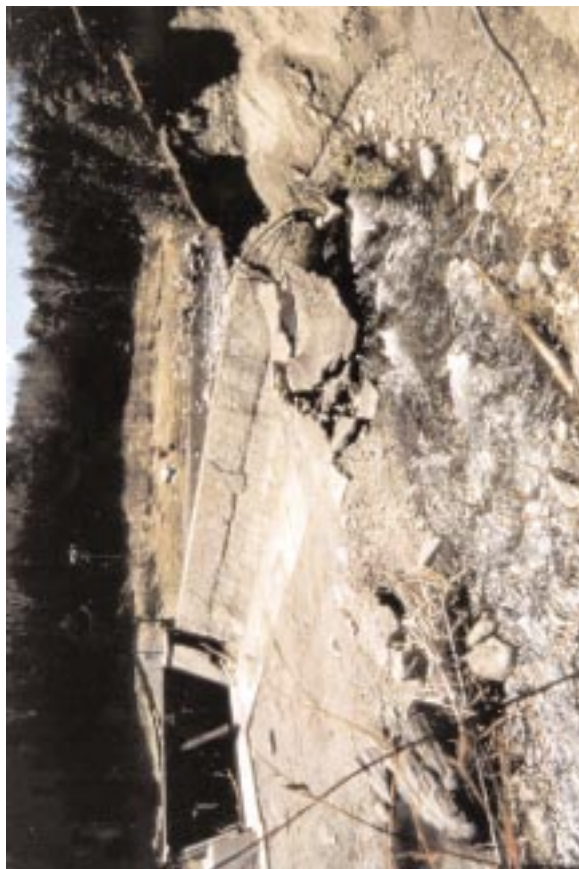
Newport No. 11 Dam - Clyde River VT

Before Removal

After Removal

The Newport No. 11 Dam will hold a place in history as the first time that Federal Energy Regulatory Commission (FERC) staff recommended dam removal as the preferred alternative in an environmental impact document against the wishes of the dam owner. The dam was built in 1957 by Citizens Utility to produce electricity. The dam quickly and thoroughly devastated the Clyde River's famed runs of six- to 10-pound landlocked Atlantic salmon. In 1994 the dam breached, rejuvenating longstanding local efforts by Trout Unlimited (TU) and others to remove the dam. Relief came in 1995, when FERC staff, who were considering relicensing the dam, made a landmark recommendation in a draft Environmental Impact Statement (EIS) to require removal of the Newport No. 11 Dam. Following a settlement with the dam owner, in 1996, a controlled explosion shattered the structure, which reconnected the river and allowed fish to move freely for the first time in 40 years.
